## Case History

Leakage of a PVC/FRP pipe for 96% H<sub>2</sub>SO<sub>4</sub> at ambient temperature

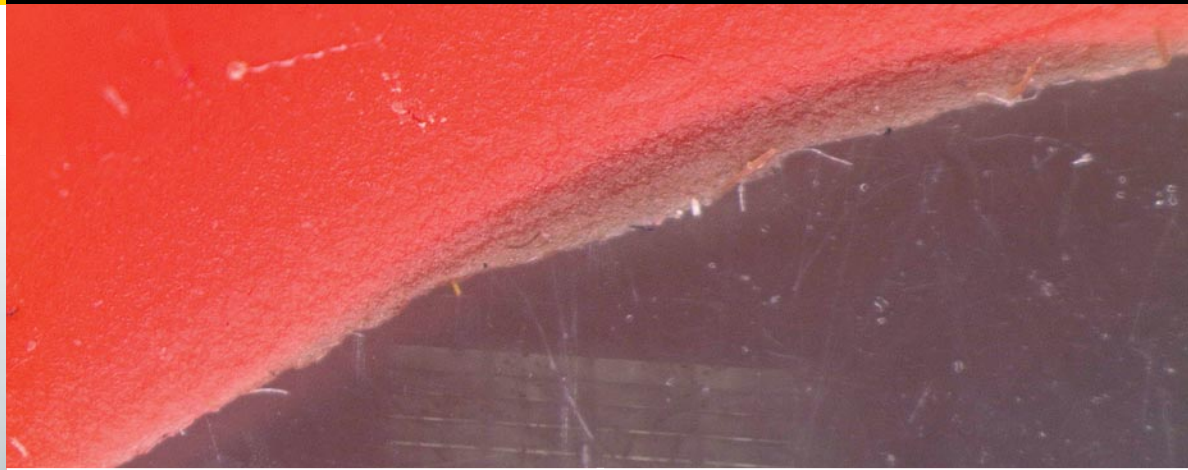
In the installation are PVC/FRP pipes DN32 with different failures. From outside a dark discoloration could be seen due to the reaction of sulfuric acid with the FRP. At one end directly at the edge of the flange the pipe is cracked.

PVC is not chemical resistant against high concentrated sulfuric acid also at ambient temperature. Due to the equilibrium reaction of sulfuric acid always SO<sub>3</sub> in different quantities is formed which is a very aggressive and oxidizing gas. Due to the reaction of sulfuric acid the PVC structure is complete destroyed (black/dark color). It remains a material with very brittle properties. In case of almost a small mechanical stress cracks can occur. At the edge of the flange is a transition from a stiff material (FRP) to a softer material (PVC). This implies an increase in stress at the transition zone and by means of a mechanical force the flange breaks.

For very high concentrated sulfuric acid PVC-U is not the best choice. It should be better to choose E-CTFE as liner material in combination with FRP out of Novolak-Vinylester. The E-CTFE liner is more resistant and less brittle in comparison to PVC.
